Re: Davidson Canyon Unique Water Nomination

DAVIDSON CANYON

Prepared by Pima Association of Governments Watershed Planning Prepared for Pima County Regional Flood Control District

February 2005

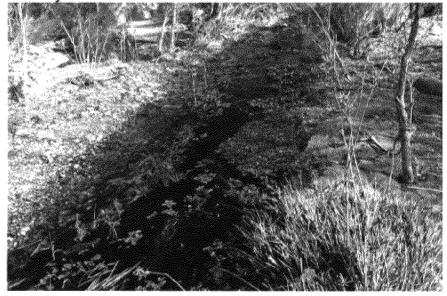
Davidson Canyon Creek, near spring south of I-10. Photograph by Linwood Smith, January 2004.

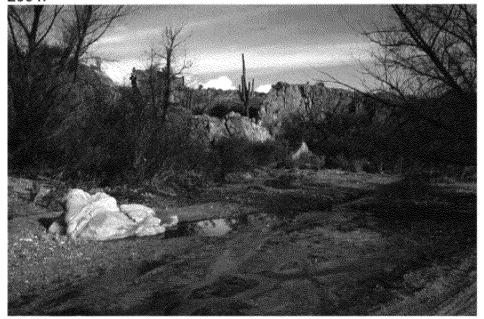
Davidson Canyon near spring south of I-10. Photograph by Linwood Smith, January 2004.

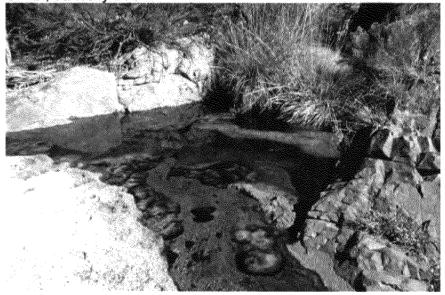
Instream pool in Davidson Canyon near spring south of I-10. Photograph by Linwood Smith, January 2004.
